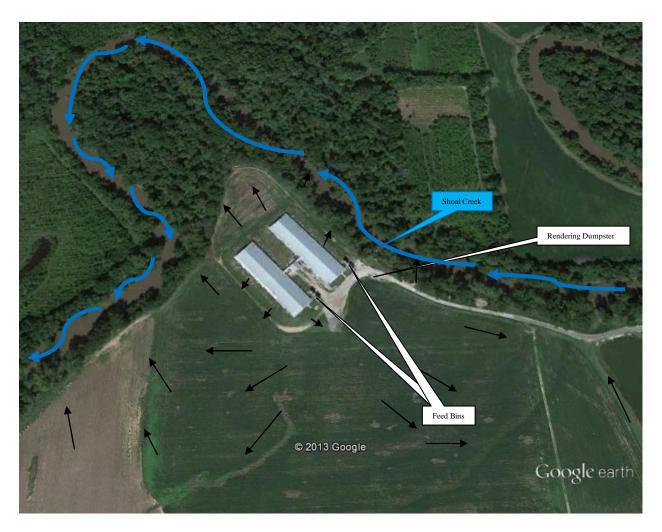
Black arrows show the direction of storm water drainage. Barns are labeled as shown. The two barns are situated on 8 foot under floor deep pits. Feed bins are located on clean concrete pads located on the northeast corner of the buildings with the feed totally enclosed. Mortalities are placed in a watertight dumpster located along the roadway to the site. The facility contained 14,000 head of swine under 55 pounds and no discharge was noted at the time of inspection.
